Observational Method for Ground Treatment of Tunnel Cross Passages in Complex Ground Conditions

This paper focuses on the design and review of the ground treatment and rock fissure grouting required to excavate tunnel Cross-Passages in the Liantang / Heung Yuen Wai Boundary Control Point Site Formation and Infrastructure Works – Contract 2 in Hong Kong SAR. The Cross-Passages were expected to go through Tuff in various degrees of weathering (Grade V to Grade III/II). The Site Investigation, SI, showed that SPTs numbers generally ranged from 30 to 50 for the Completely to Highly Decomposed Tuff, CDT / HDT, with localised values as low as 6. Ground Treatment consisting of permeation and rock fissure grouting as well as 120° pipe roof / canopy tubes, was required to ensure not only the stability during excavation but also limit the groundwater inflow. The SI determined in-situ permeabilities ranging from 1×10^{-5} to 1×10^{-6} m/s for the CDT and a 21m long probe hole recorded a water inflow in excess of 60 l/minute. A discussion relative to the methods employed for drilling, e.g., pressure balance drilling system, drilling alignment tools used, and grouting techniques, e.g., microfi

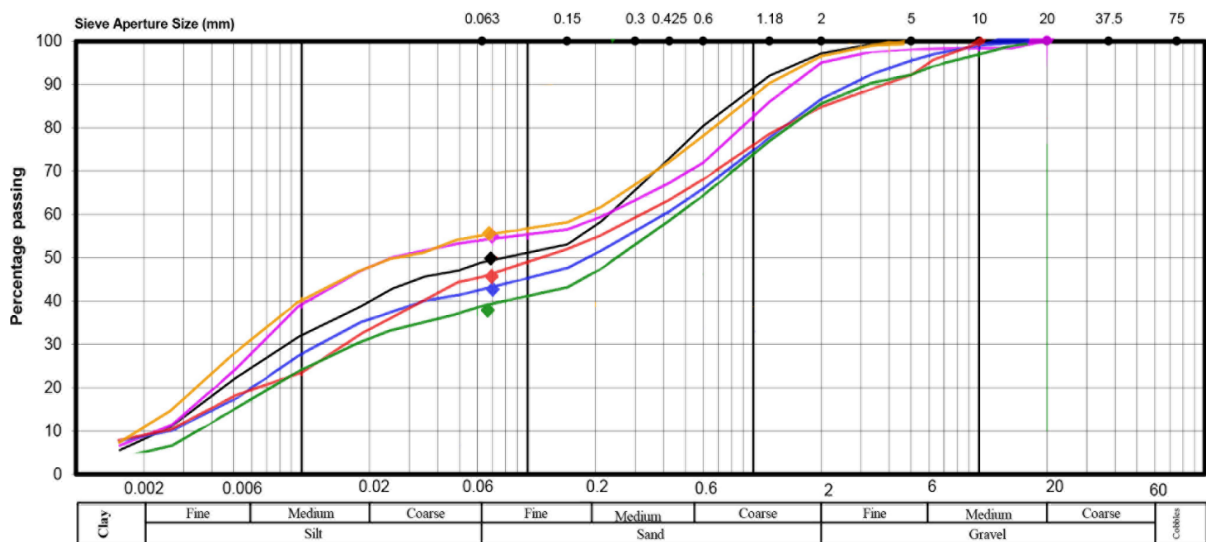
Figure 1: Particle Size Distribution from Samples at CP42

Site investigation campaigns identified that the four CPs would go through Tuff in various degrees of weathering (Grade V to Grade III/II). The Completely to Highly Decomposed Tuff, comprised of medium dense to dense silty / clayey Sands and stiff to hard sandy Silts / Clays, generally recorded Standard Penetration Tests, SPT, ranging from 30-50. However, localized SPT values as low as 6 were recorded indicating that less dense / softer pockets of material existed along some of the CP's alignment. Figure 1 shows the Particle Size Distribution, PSD, of samples collected at CP42. The PSD determined that the CDT / HDT was mainly sandy Silt, slightly gravelly at some of the samples, and with fine content ranging from 39% to 55%.

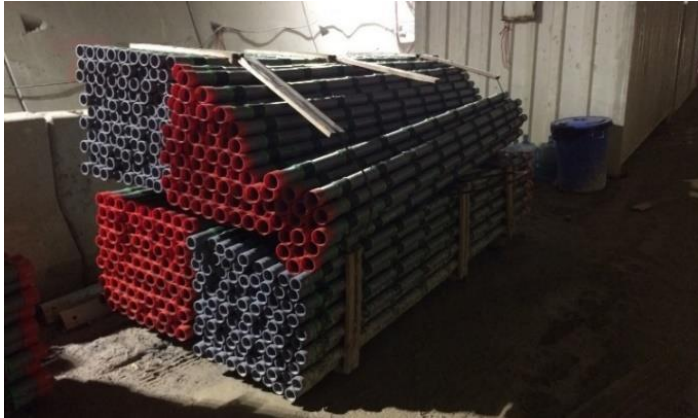
Plate 3: TAM Grouting Pipes

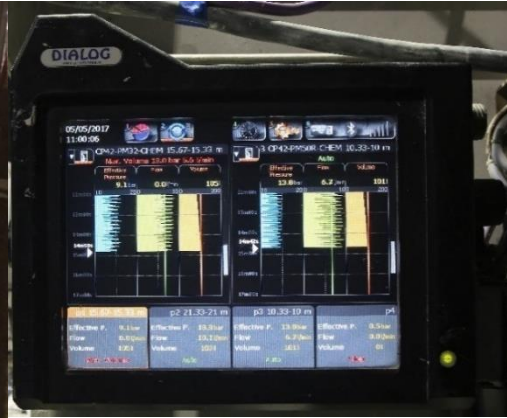
Plate 4: Grouting Dialog

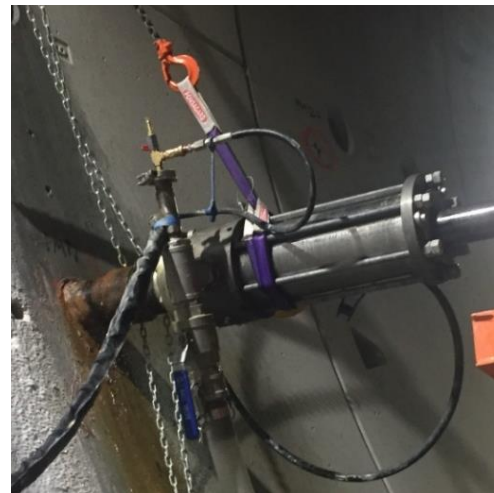
Plate 5: Blow out Preventor

Blow out preventors are usually only used in specific drilling applications, and therefore, most drilling staff needs to be thoroughly briefed on how to use the equipment to ensure proper utilization and minimize wear and tear. It was specified that the system would be used for all drilling holes of all CPs, which proved to be counterproductive. When used in Grade III/II rock the Blow Out Preventor was not really required since the risk of drillhole collapse was minimum and water inflow was manageable. Therefore, using the equipment in these geological conditions led to improper use and an underappreciation of the equipment’s capability. Since maintaining the pressure was not required for stability, the choke was being continually balanced as it benefited production. Afterwards when the drilling progressed to the Grade V Tuff the habit of continually balance the choke pressure was carried on. This behavior watered down the drilling fluid, bentonite, causing drillhole collapses, which would

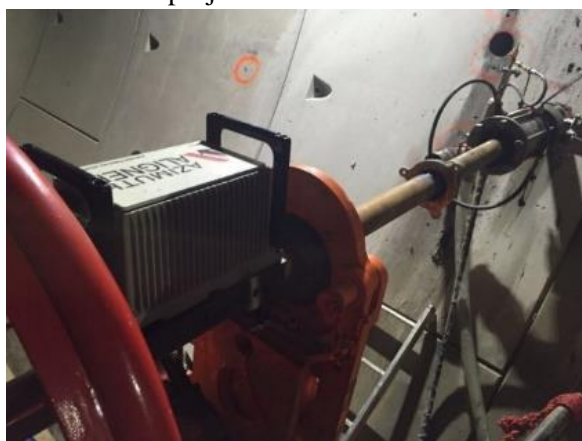
Plate 6: Aligner unit, clamped to leading drill rod

The unit is clamped to the lead rod and provides a real time readout of the current dip and azimuth whilst providing the closure distance to the planned / design dip and azimuth. This works by measuring the divergence of a laser beam by background magnetism and unaffected by ferrous objects. On site this was used for the alignment of the core barrel for concrete coring and for the alignment of the drilling rig. The tool provided accuracy to 0.2° , which equated to 60mm at 15m length.

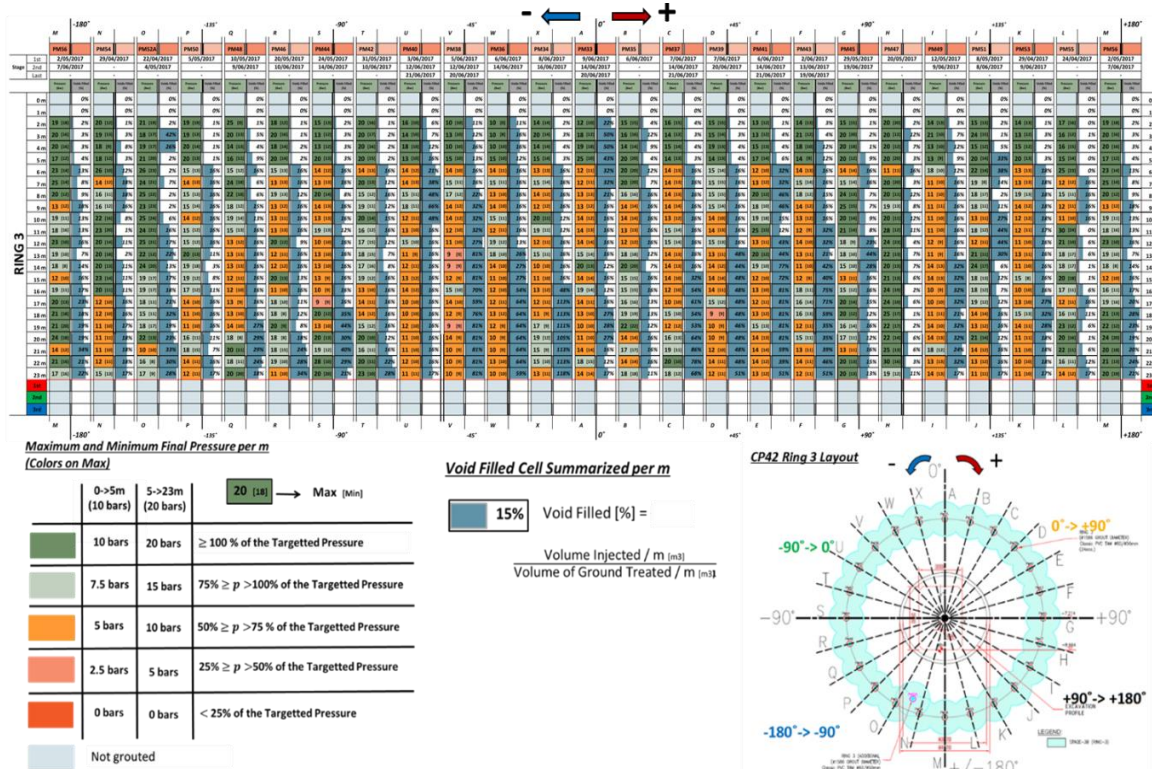
Figure 11: Chemical Grouting Cartography CP42 Ring 3

The Grouting Cartography is a Visual Management Tool, which was implemented to track the grouting progress, ensure a proper grouting strategy, and guarantee the performance of the grouting treatment, see Figure 11. The Grouting Cartography consists of spatial mapping of the treatment zone displaying the intake of grout and grouting pressure achieved at each grouting stage. The grouting cartographies supported the technical decisions and were reviewed on a bi-monthly basis. Firstly, they were used to define the re-grouting strategy, e.g., where the grout intake and / or pressure were not satisfactory. For example, the zones in which the manchettes did not achieved a minimum of 2.5 bars were re-grouted. Secondly, the cartographies were key to decide when to transition from the Microfine Cement Stage to the Chemical grout. When it could be observed that the MFC already filled in the voids and increases of pressure did not result in further intake it meant that the treatment could be switched to the next stage with the Chemical Grout. Finally, the grouting cartography was also used to monitor the grouting performance in zones where drillholes had recorded non-compliant deviations. The grout intake of adjacent holes would be reviewed and re-assessed to ensure that the volume of soil to be treated could be achieved despite the deviations.

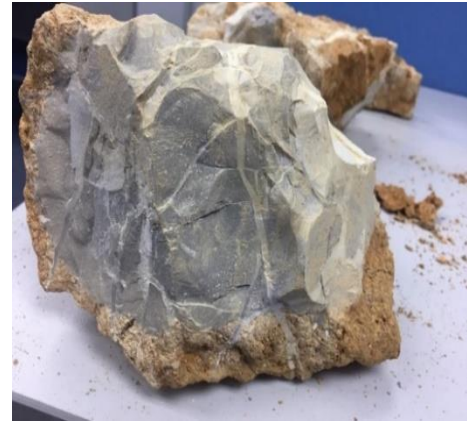
Plate 9: Treated Excavated Soil Block

The excavation progressed in a dry and stable manner, Plate 8 and Plate 10, and without additional grouting being required. Plate 9 shows an excavated grouted soil block where it is visible that the Microfine cement penetrated through the sleeve grout. Lattice girders and shotcrete were used as the primary lining of the Cross Passages and was placed during the excavation as planned and prior to the permanent structural lining, Plate 11. The ground treatment allowed for an efficient excavation that was able to meet the planned programme and without adverse impact, e.g. water drawdown outside the CP.

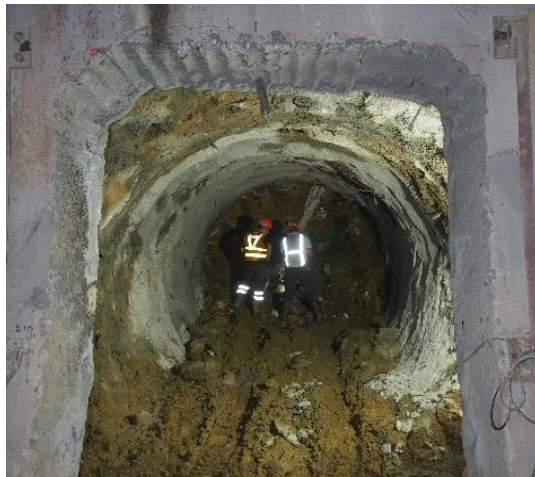
Plate 10: Cross Passage Excavation (View from Permanent Opening)

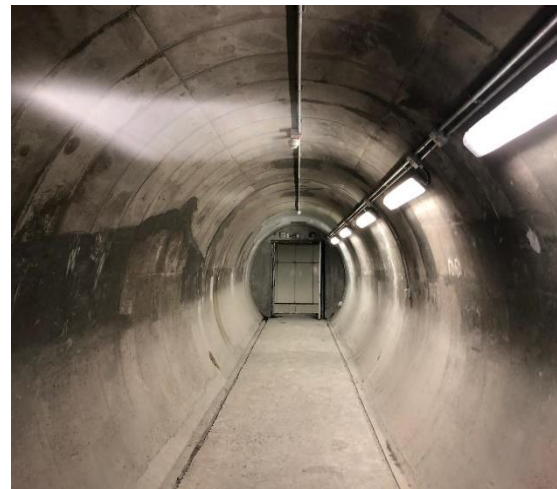
Plate 11: Cross Passage with Permanent Structural Lining
