Managing Landslide Dam Failure Risks

ABSTRACT

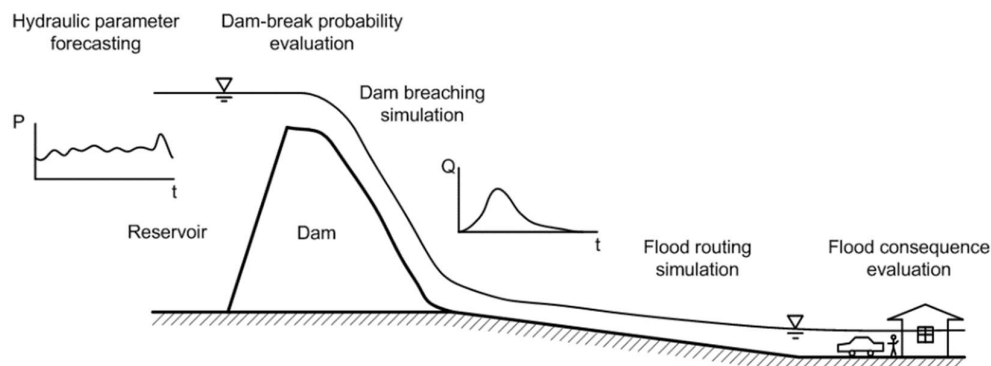
Fig. 1. Some main tasks of dam-breaching risk analysis

This paper outlines the principle of emergency dam-risk management in both time and space. Two recent cases are presented to illustrate the principle. The evaluation of dam risks covers a large area along the river from the catchment upstream of the dam to the potential flood areas downstream of the dam (Figure 1). Several steps are often followed when evaluating the risks: hydraulic parameter forecasting, dam-break probability evaluation, dam breaching simulation, flood routing simulation and flood consequence evaluation. Risk mitigation measures and their effectiveness shall be evaluated in an iterative manner.

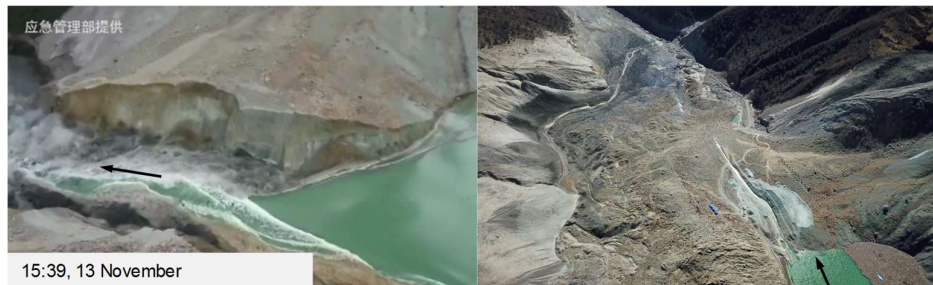
Figure 2. The Jinsha River landslide dam breaching in November 2018.

Jinsha River landslide dam failure in 2018. The Jinsha River, the upper reach of the Yangtze River, was dammed twice recently at Baige, Tibet, one on 10 October 2018 and the other on 3 November 2018. Accordingly, two large landslide dams, 61 m and 96 m in height to the lowest dam crest, were formed in a three-week interval. In managing the landslide dam risk, rapid prediction of the dam breaching hydrograph and breach geometric parameters of the two landslide dams was performed before the breaching of the two landslide dams using both erosion-based empirical equations and numerical simulation. A diversion channel 15 m in depth was excavated on the second dam, which successfully lowered the breaching peak flow rate to 33,900 m³/s (Figure 2). Corresponding flood routing analysis was also performed to evaluate the potential flood zones and facilitate evacuation of people up to 700 km downstream the dam. Existing reservoirs downstream the dam were utilised to regulate the dam-breaching flood.

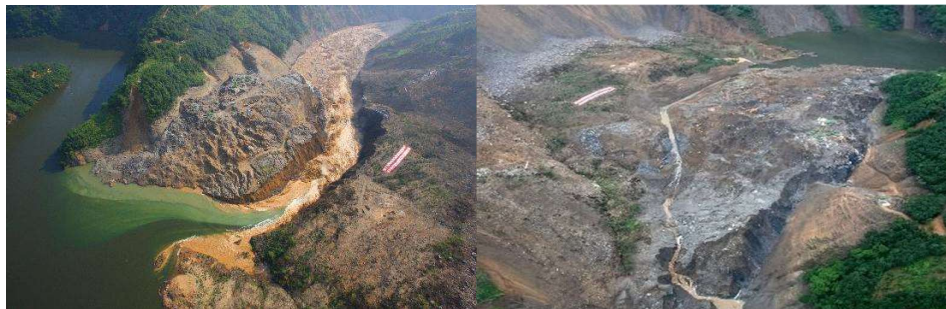
Figure 3. The Tangjiashan landslide dam breaching in June 2008.

Tangjiashan landslide dam failure in 2008. The Tangjiashan landslide dam was formed during the 2008 Wenchuan earthquake, with a height of 82-124 m, a length along the river of 803 m, a length across the river of 611 m, and a lake volume of 316 million m³. Rapid and numerical analyses were performed to estimate the dam-breaching flood hydrograph and flood routing. A staged risk assessment was conducted to evaluate the risks at different stages based on hydrologic and geological information available at each stage (Peng and Zhang 2013). A 12 m deep division channel was excavated to reduce the risk. More than 0.2 million people were evacuated 10 days before the dam breached.
