# Innovative Synergy between Slope Upgrading and Ecological Conservation in Preventive Maintenance Programme

Feature No. 15NE-B/C273 located at Shek O Road was a selected roadside man-made slope feature to be upgraded under Prevention Maintenance Programme of HyD. The feature is an approximately 125m long soil and rock cut slope. The cut slope has a maximum height of 18m and an average slope angle of 45°. The southern end and the crest of the middle portion of the feature was covered in vegetation (30%) while the rest of the feature was covered in shotcrete (70%). During the course of the slope upgrading works, Landscape Division of HyD expressed important concern on the high amenity value of the existing woodland at the southern end of the feature (Figure 1, Plates 1 and 2). The preservation includes the existing trees and species of conservation value and also the natural vegetation was of importance during construction phase.

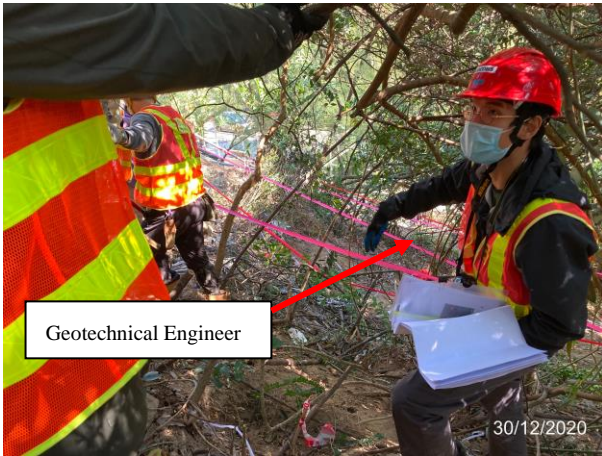
Plate 3: Ecological Condition Survey in woodland area (ECS) conducted by Landscape Contractor and Ecologist / Plant Specialist with Geotechnical Engineer

Plate 4: Locating Species of Conservation Importance by Ecologist / Plant Specialist

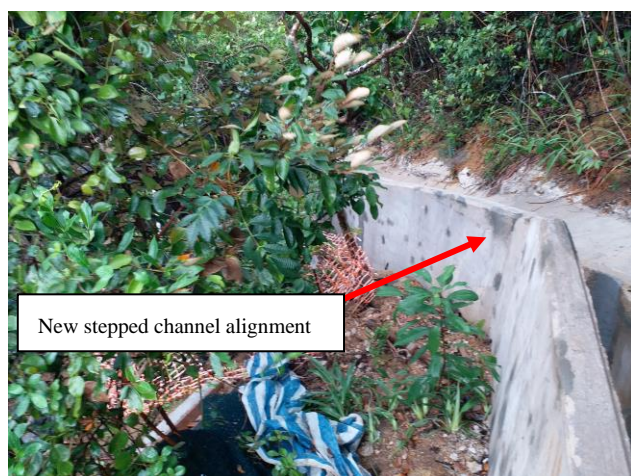
Plate 5: A new stepped channel alignment was counter-proposed to preserve the flora species of conservation importance fenced off by an orange net

Plate 6: Condition of natural woodland area when assigning erection of access

3.	Surface Drainage System and Maintenance Access	<ul style="list-style-type: none"> <li>A new alignment of the stepped channel was counter-proposed as the position of the original proposed 300mm U-channel with concrete apron and 300mm high upstand is in conflict with the vegetation growing on the natural slope.</li> </ul>	<ul style="list-style-type: none"> <li>To minimize the impact on the woodland area so that natural rainwater will not be completely diverted away from the vegetation and to lessen the visual impact of the stepped channel leading to the slope toe.</li> </ul>
		<ul style="list-style-type: none"> <li>The portion of 300mm U-channel with concrete apron in the vegetated slope portion was deleted accordingly. A 300mm diameter downpipe was proposed to convey the surface runoff rather than a stepped channel.</li> </ul>	<ul style="list-style-type: none"> <li>To suit the actual site conditions and reduce the extent of excavation and concrete works on the slope surface in woodland area (Plates 5 and 6).</li> </ul>

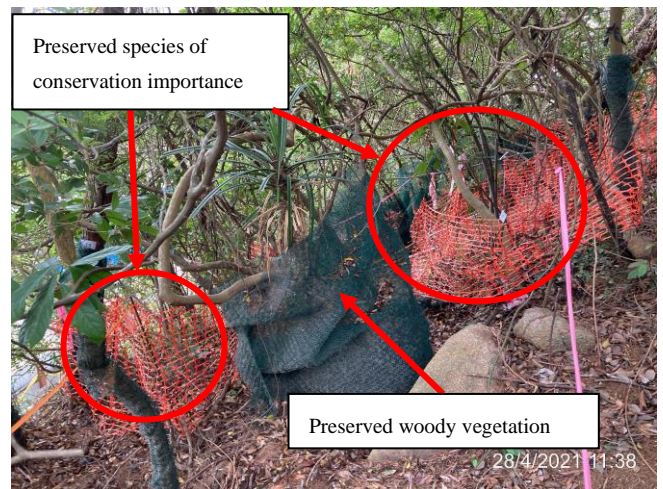
Plate 7: A practical segment of temporary working access among preserved vegetation

Plate 8: Woody vegetation was preserved by a green fence while orange fence was used for species of conservation importance. Preserved woody climber provided a shaded canopy layer to sustain the microhabitat.

After conducting the ECS, the draft works alignment was marked temporarily using the colour strips by fitting the mosaics of dense vegetation. All existing trees, species of conservation importance and woody vegetation were appropriately cordoned off by orange net (Plates 7 and 8). For secure protection, all the area outside the colour strips of lands reserved for soil nail head / temporary access and working platform were also cordoned off properly (Plate 7). Photo records upon completion of fencing was submitted to HyD for obtaining their consent for erection of physical temporary access and working platform.

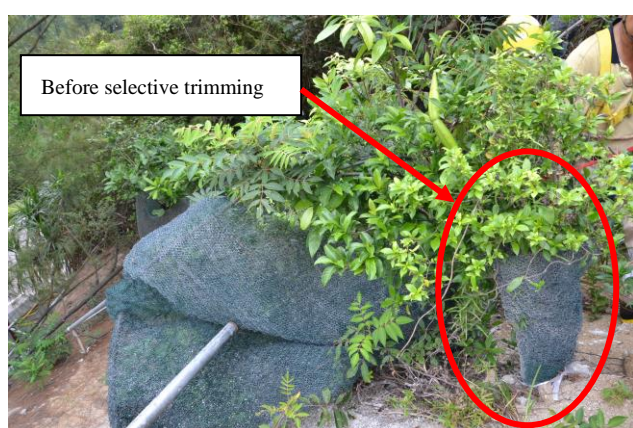
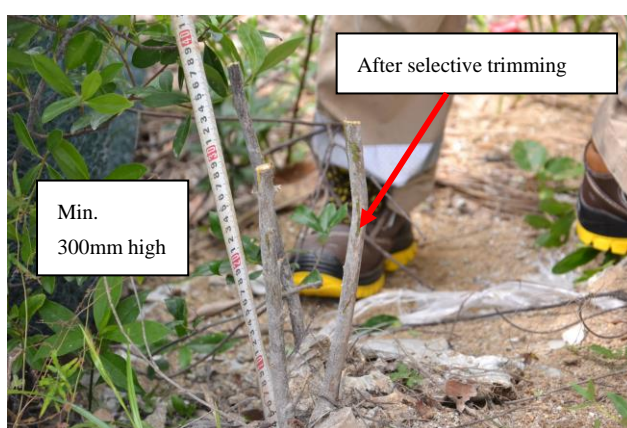
Plate 9: Before selective trimming during erection of scaffolding and working platform for soil nail Row BH in woodland area

Plate 10: After selective trimming, erection of working platform will avoid soil compaction and risk of stepping on the remaining stems by the workers

When a localized clearance was unavoidably, the selective trimming of woody plants would be carried out under the supervision of the Ecologist / Plant Specialist and the Geotechnical Engineer. Non-woody herbaceous plants and grass was not limited for site clearance. If the common plant species without conservation importance was affecting the erection of the working platform, the authorized Landscape Contractor (but not other site workers) conducted the selective trimming (Plates 9 to 12) and pruning of the hanger and overhanging branches affecting headroom as identified on site during inspection also had to be carried out.

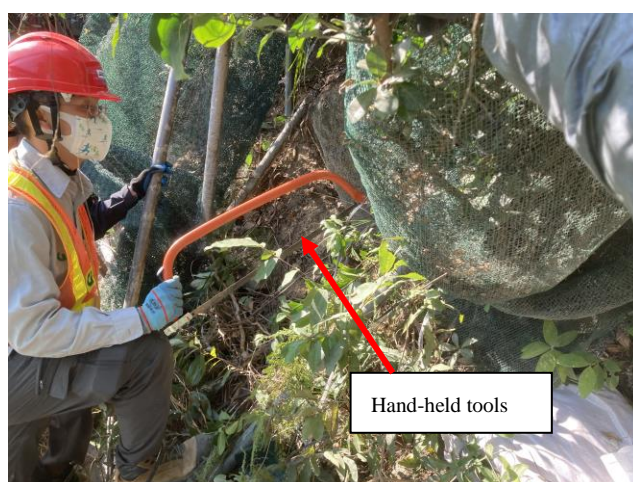
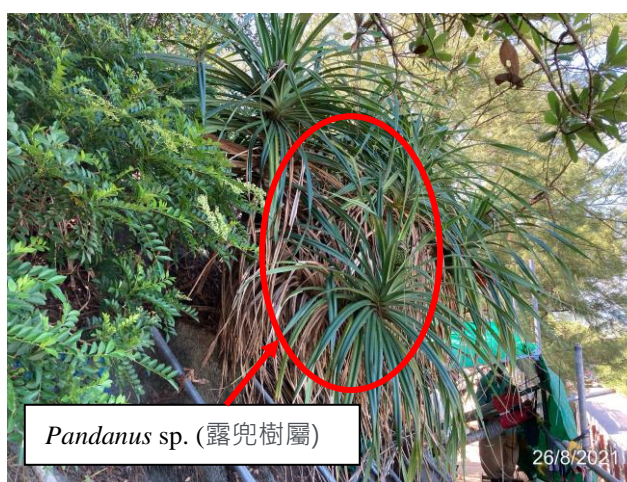
Plate 11: Only hand-held tools were allowed for selective trimming. Plant identification and extent of trimming was confirmed by the Ecologist before trimming.

Plate 12: Adventitious root system of *Pandanus* sp. (露兜樹屬) allows a quicker recovery against selective trimming of its spiky leaves that obscuring the work path. The clutch was preserved as a good coverage at the boulder zone.

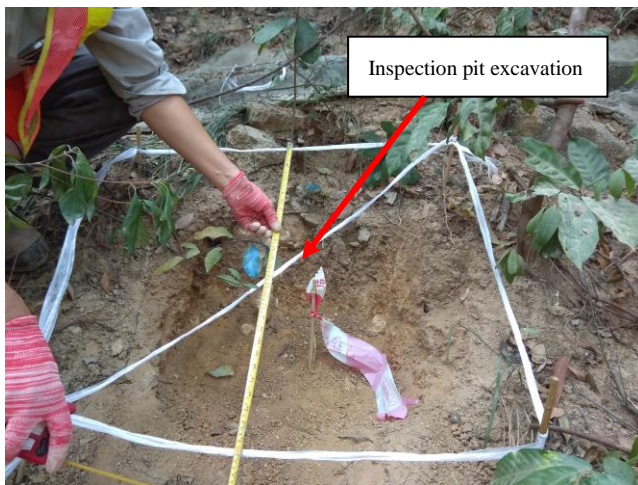
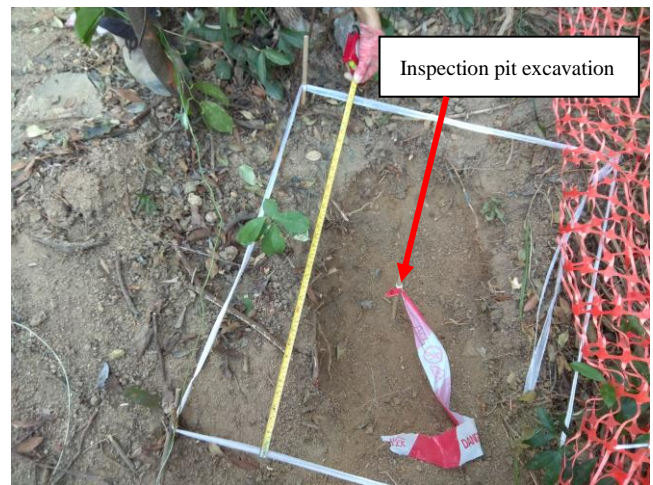
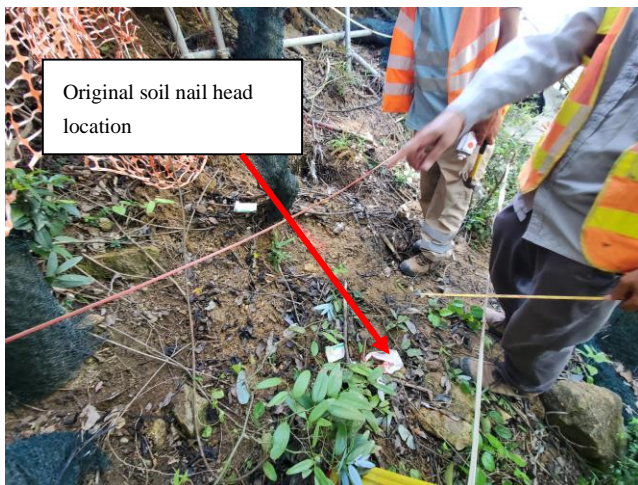
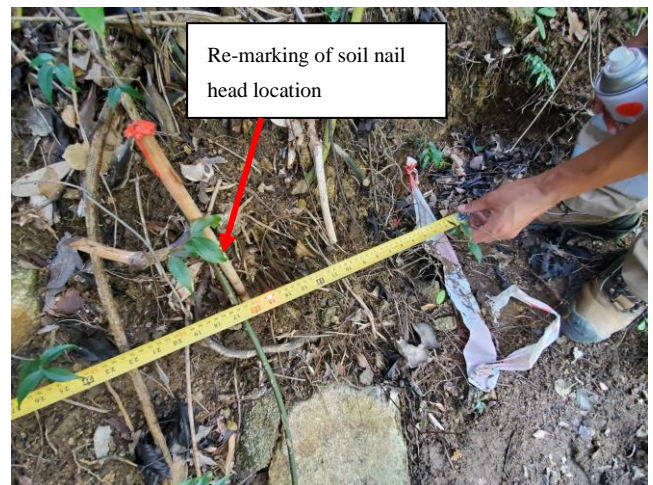
Plate 13: Inspection pit excavation for Row BG Soil Nails

Plate 14: Inspection pit excavation for Row BF Soil Nails

Plate 15: Original soil nail head locations at Row BG

Plate 16: Re-marking of soil nail head locations at Row BG

A Certified Arborist of the International Society of Arboriculture (ISA) was assigned to supervise and inspect the inspection pit excavation on-site in order to prevent major tree roots damage during excavation. Manual excavation of inspection pit at each soil nail location within a tree protection zone (TPZ) was adopted to confirm any tree roots at the proposed soil nail location (Plates 13 and 14). If significant tree roots were encountered in the inspection pit, the soil nail had to be re-adjusted to minimize adverse impact to the existing trees (Plates 15 and 16). No major tree roots were observed in the excavated inspection pits for this site. Photographic records of each of the inspection pit were provided and the amount of root loss was recorded. The exact location of the adjusted soil nail head was confirmed on-site and recorded in the revised working drawings.

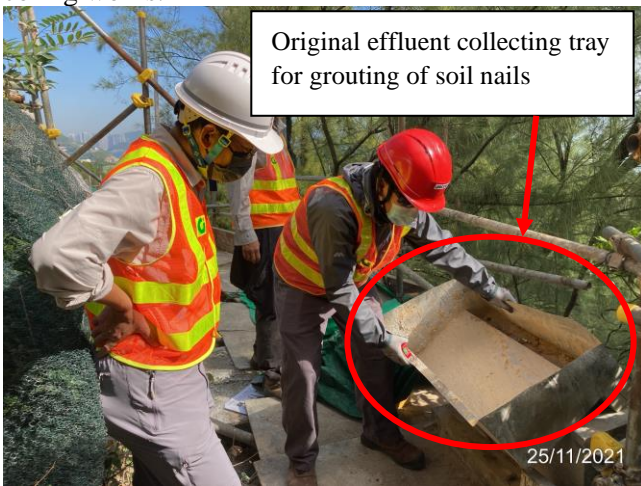
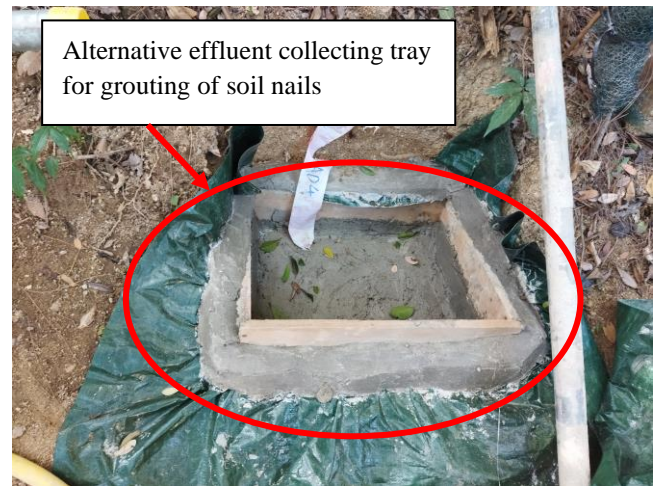
Plate 17: Tailor made effluent collecting tray using steel plate

Plate 18: Alternative effluent collecting tray using cement sand mortar and plastic sheet

A “method statement for soil nailing works in woodland area” (“MS”) appending the sequence of works had to be submitted for approval prior to commencement of soil nailing works within the woodland area. According to the MS, shorter steel bar combination was adopted for easier transportation among preserved vegetation. A steel effluent collecting tray was tailor-made by the Contractor and placed in the excavated soil nail head for water collection during the coring works (Plate 17). Adequate sand bags were also provided at the bottom of the tray as contingency measure. Effluent was then pumped to a sedimentation tank located outside the existing woodland. The route for effluent diversion was shown in the method statement for approval. Based on the experience of grouting for first two rows soil nails in woodland area, it was observed that longer construction time was required as only two nos. of effluent collecting trays could be placed for better control. After that, the Contractor proposed an alternative effluent collecting tray by using cement sand mortar and plastic sheet (Plate 18). This alternative tray not only could be placed in greater numbers within the woodland area for shortening the construction time, but also provided a good collection of effluent during coring works.

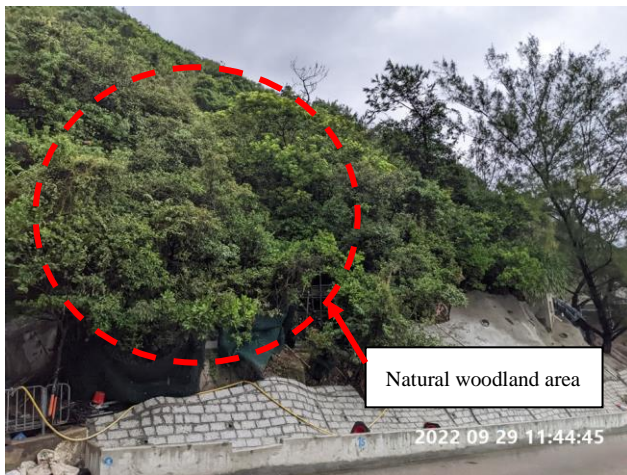
Plate 27: Preserved woodland patch after completion of construction phase in late wet season. (Date: 29/09/2022)  
Note that native parasitic climber *Cuscuta chinensis* (菟絲子) has been depressed by the recovering floral community. No invasive plants compete in a rather intact community of native species in various forms.

Overall condition of preserved trees, species of conservation importance and woody vegetation; as well as the implementation of mitigation measures of plant preservation were monitored monthly by the Ecologist / Plant Specialist throughout the 32-month construction phase (January 2020 to August 2022) (Plates 19 to 28).
