# Elevating Geotechnical Excellence: Novel Practices and Innovative Solutions in Hong Kong

*C M Wong & Associates Ltd. Hong Kong*

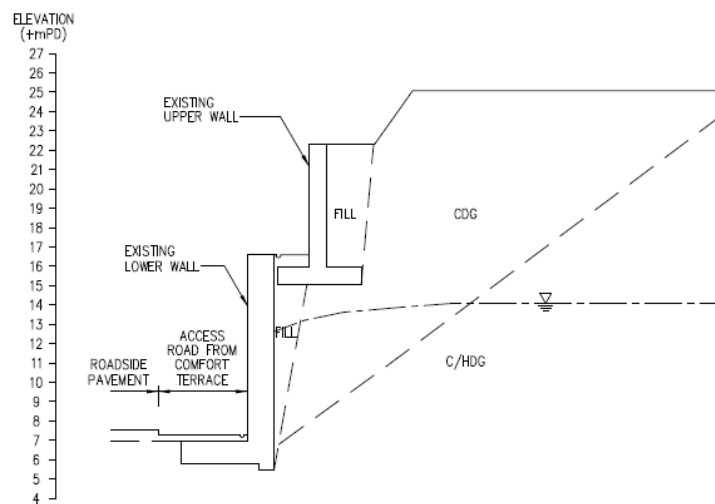
Figure 3-1: Typical section of the retaining wall before upgrading works

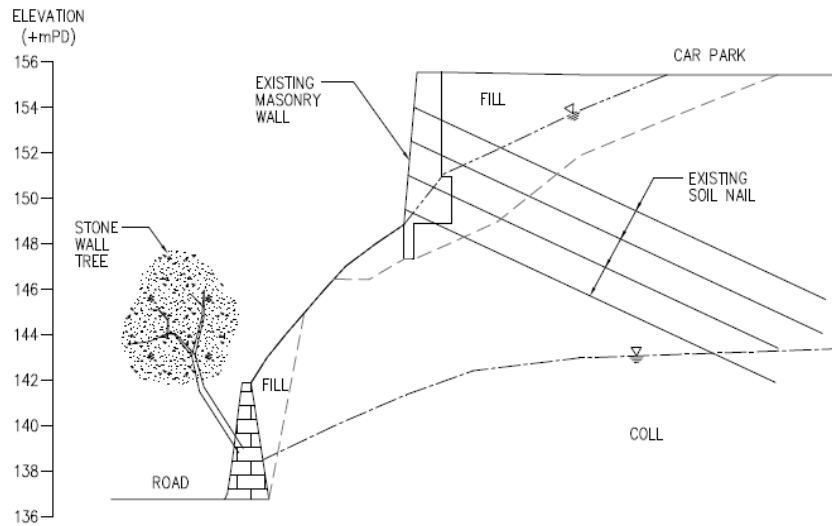
Figure 3-4: Typical section of the cut slope with retaining wall before upgrading work

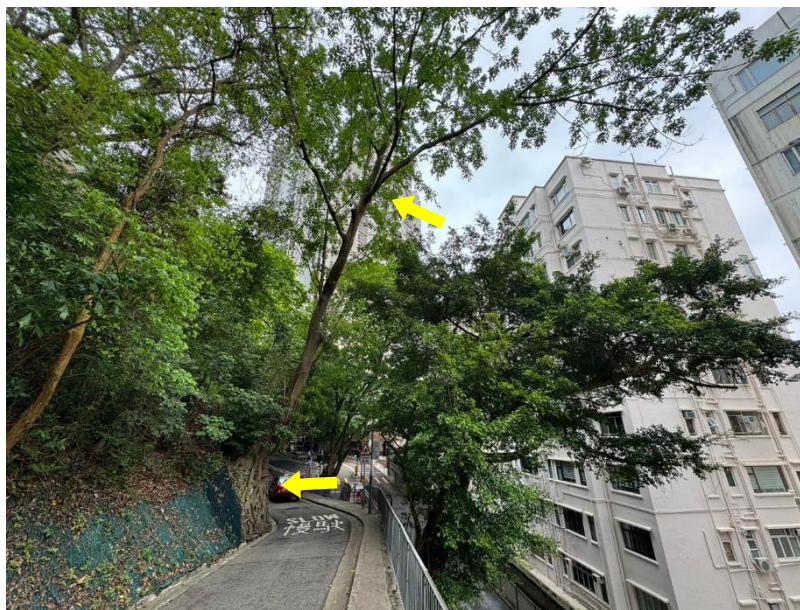
Plate 3-6: Condition of the stone wall tree in May 2024

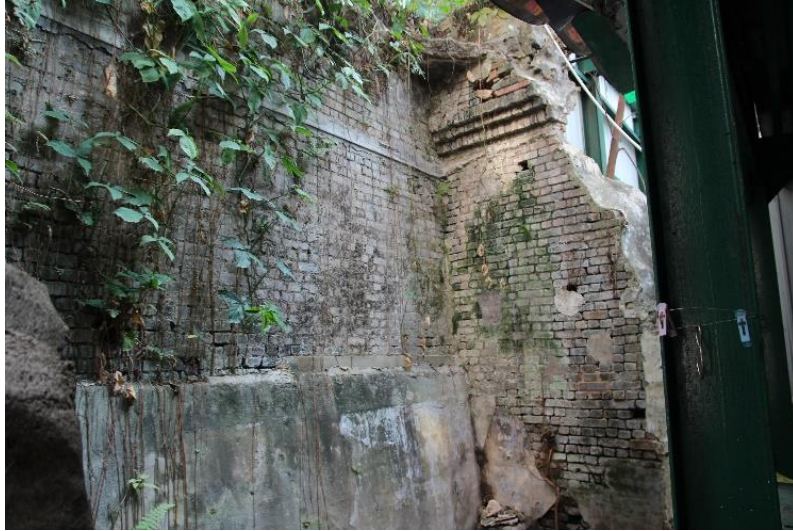
Plate 3-7: Condition of subject retaining wall and one of the connected side wall before commencement of construction works

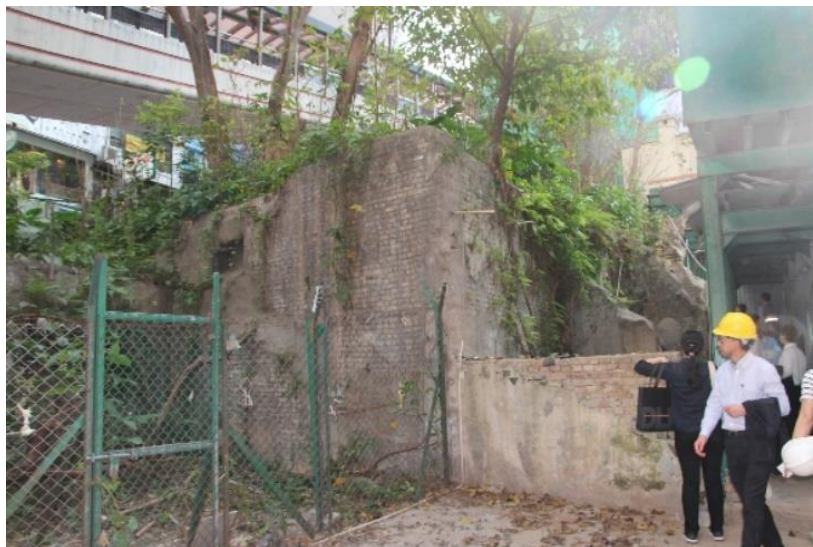
Plate 3-8: General view of condition of the subject retaining wall before commencement of construction works

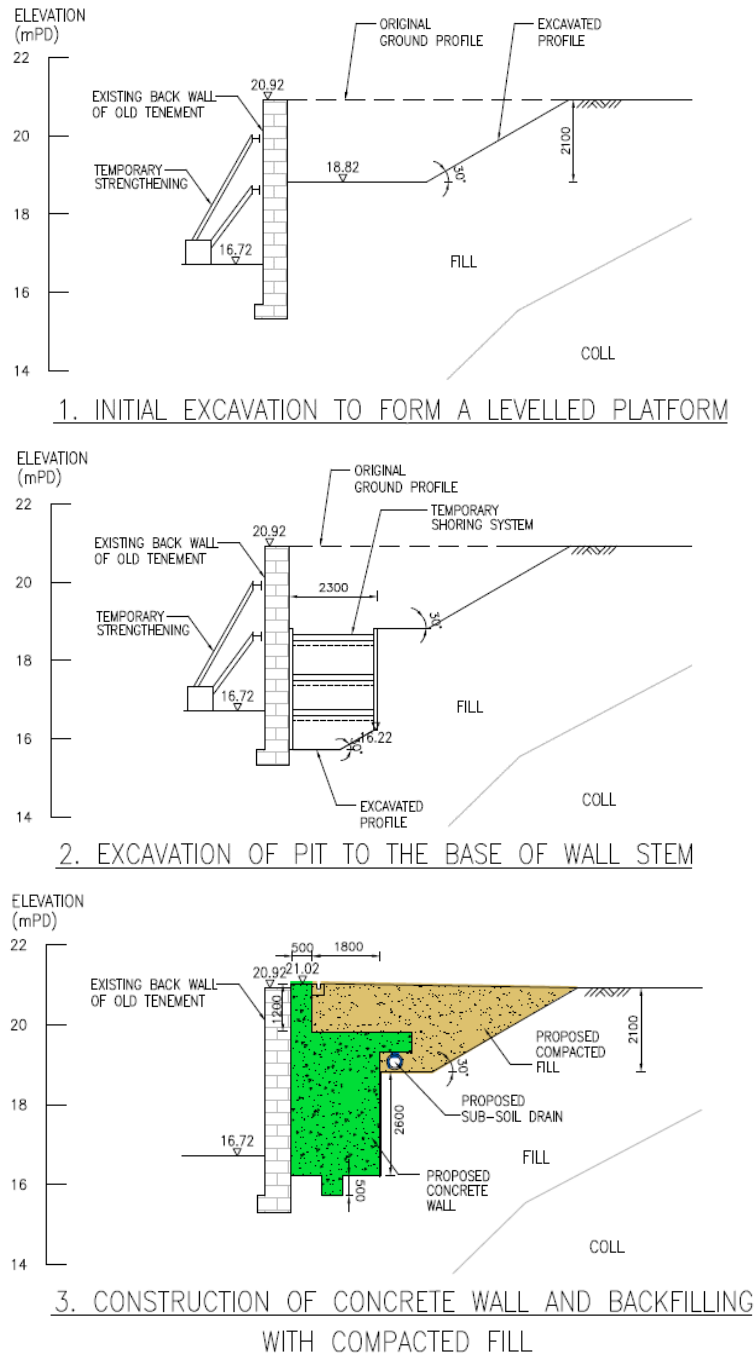
Figure 3-6: Typical section of the upgrading works.

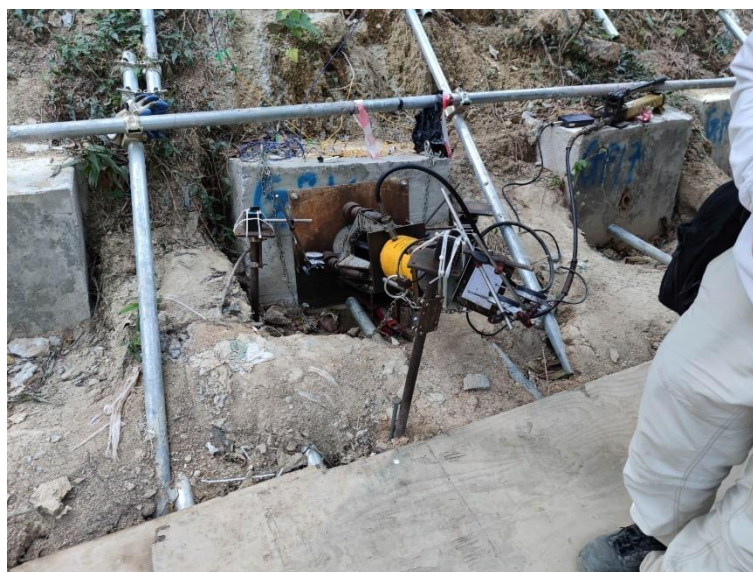
Plate 3-14: Pull-out test for glass fibre reinforced resin soil nail

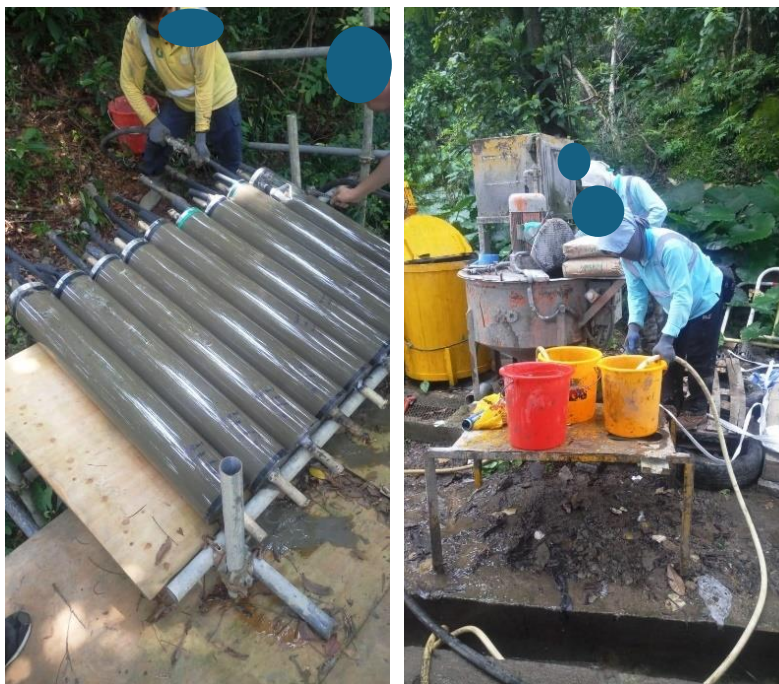
Plates 3-15 & 3-16: Filled moulds for simulated grouting exercise (left), mixing of ECC grout during site trial (right).

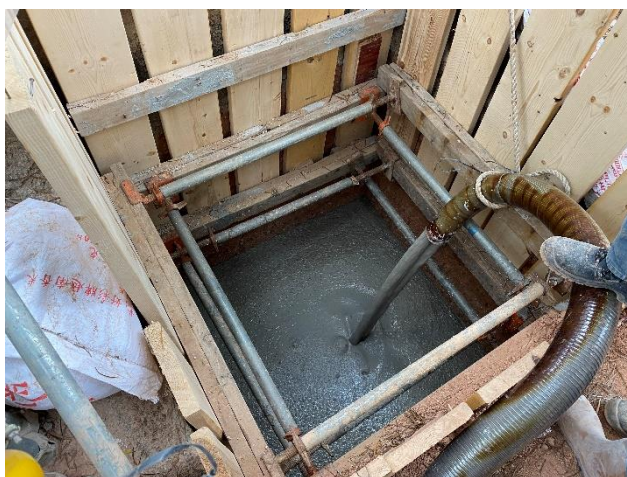
Plate 3-17: Backfilling of a pit by self-compacting material during site trial

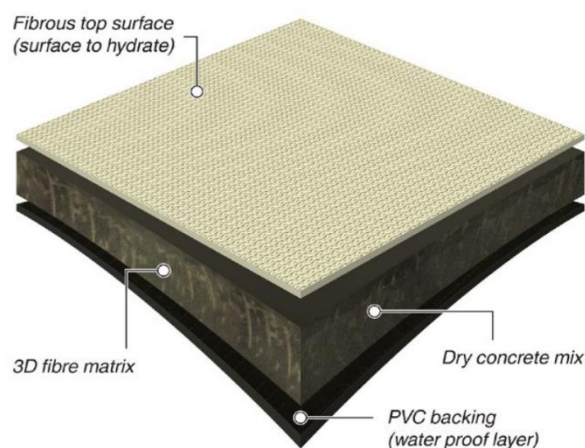
Figure 3-8: Composition of Concrete Canvas (Concrete Canvas Ltd., 2022)

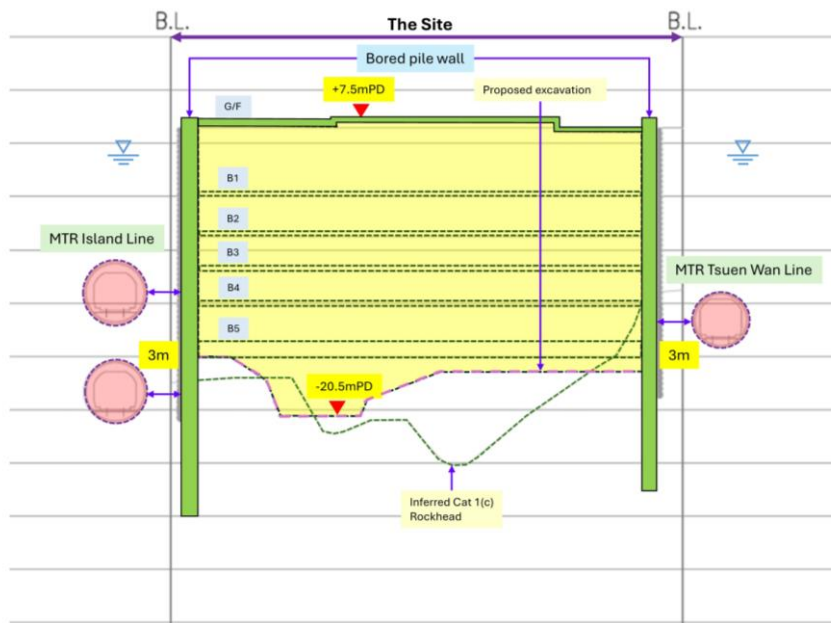
Figure 4-2: Section of Deep Excavation Works at Murray Road Site, Central

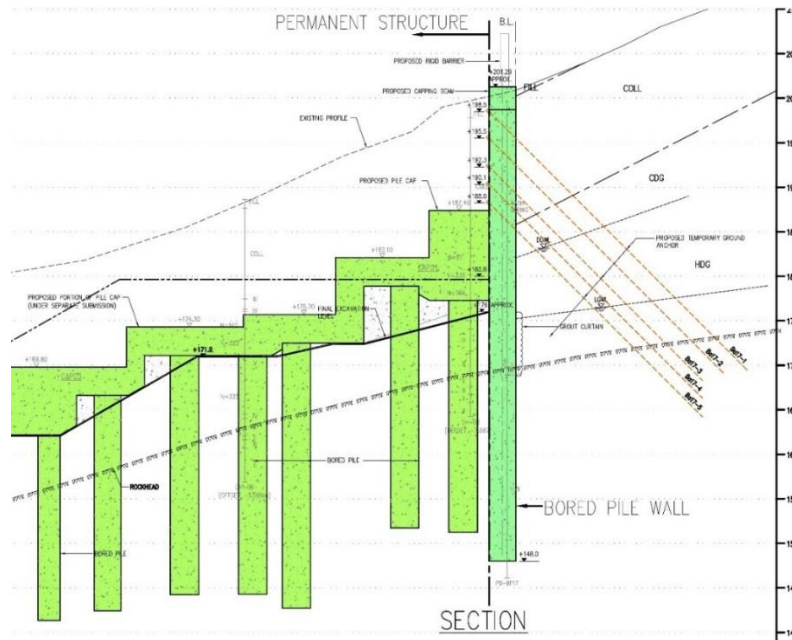
Figure 4-7: Typical Cross Section at the North Boundary of Residential Development in Tai Wo Ping

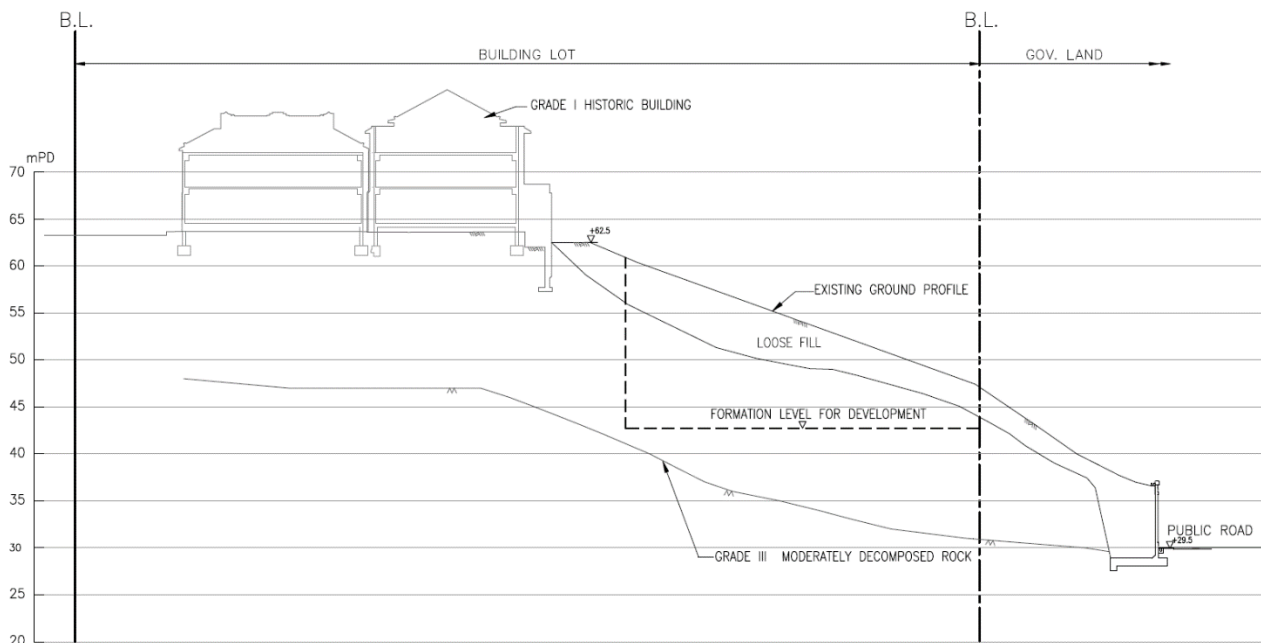
Figure 4-9: Geological Profile of Grade I Heritage Building and the Development in Stanley
